UNITED STATES
DEPARTMENT OF THE INTERIOR
BUREAU OF MINES

Subject: Report on investigation of minor coal-mine bump, No. 2 mine,
Chafin Coal Company, Rita, Logan County, West Virginia,
September 30, 1960.

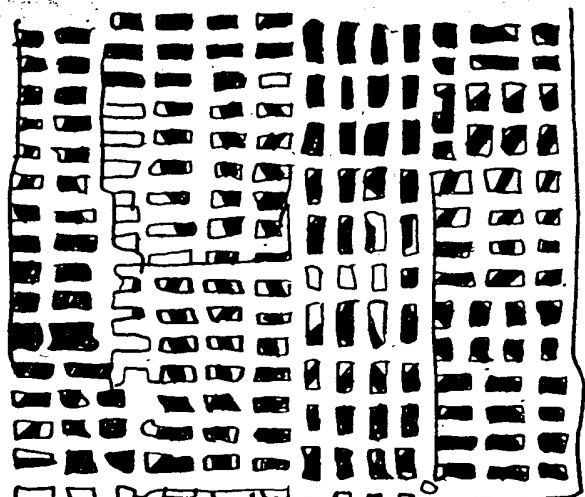
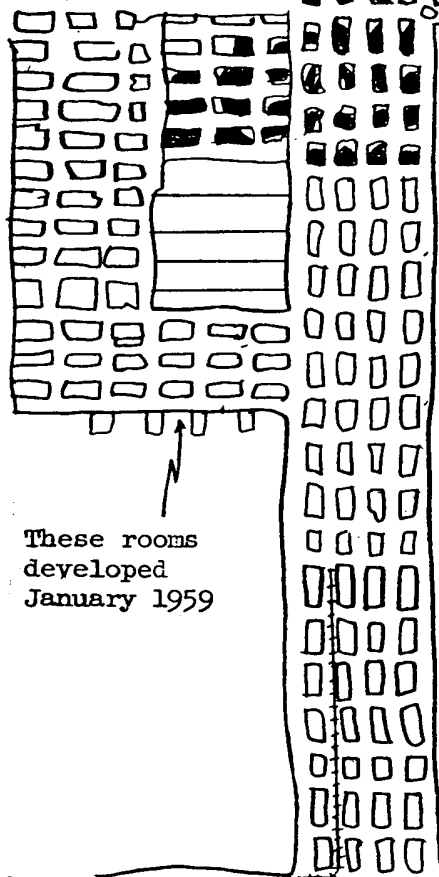
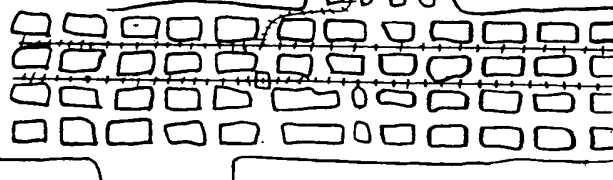
SKETCH B

The system and the extent of mining and the comparative dimensions of the coal pillars in the 4 north section prior to the coal-mine bump are illustrated in Sketch B. Location of the working faces and of the men and equipment following the outburst and the extent of the area affected are shown in Sketch A.

The 4 north entry chain pillars (from the entrance to 4 north to the line of extraction) varied in dimensions from about 35 to 70 feet in length and 20 to 30 feet in width. It will be noted from Sketches A and B that the room pillars likewise varied in dimensions. The room pillars involved in the bump varied from 35 to 80 feet in length and from 24 to 55 feet in width. It will be also noted from Sketches A and B that the No. 4 room pillars on the right side, which were adjacent to the previously mined-out panel of rooms and obviously within a highly stressed zone, were greater in dimensions than any of the surrounding pillars. Furthermore, these 3 pillars likewise varied individually from 45 to 80 feet in length, however, each of them was 55 feet in width.

From Sketches B and C, it will be noted that coal pillars and pillar remnants of various dimensions were left unmined in the gob areas of 3 north and 4 north. These unmined pillars and pillar remnants undoubtedly delayed and/or prevented the thick overlying roof from caving as desired, thus likely imposing additional stress on the newly developed room pillars, especially the larger pillars in No. 4 room. It was observed during this investigation that the immediate roof stratum, ranging from 30 to about 60 inches in thickness had fallen at some locations in the mined-out area in 4 north; however, the main roof, insofar as could be ascertained, had not caved in that comparatively long spans of the main roof could be seen extending into the gob.
